PRESTONS CLIFFS

INVENTORY FORM FOR STATE HISTORIC SITES SURVEY

Preston's Cliffs

On Calvert Cliffs Nuclear Power Plant Property, Calvert Cliffs Parkway

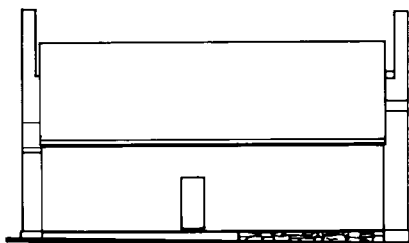
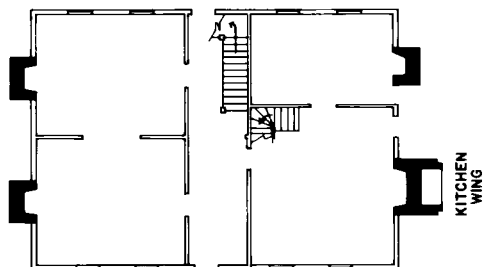
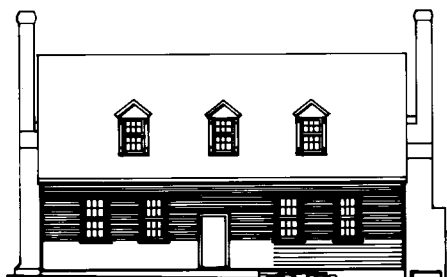
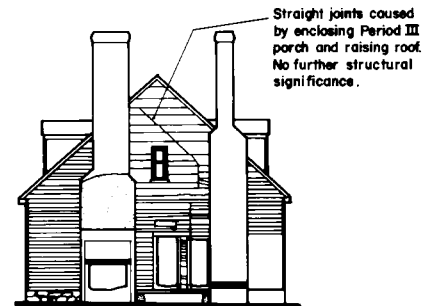
CT 59-A

PERIOD I: c. 1750-1810

PERIOD II: Before III

PERIOD III: c. 1810-1830

PERIOD IV: Later 19th c.
As shown 1971

GROUND FLOOR PLAN

EAST ELEVATION

NORTH ELEVATION

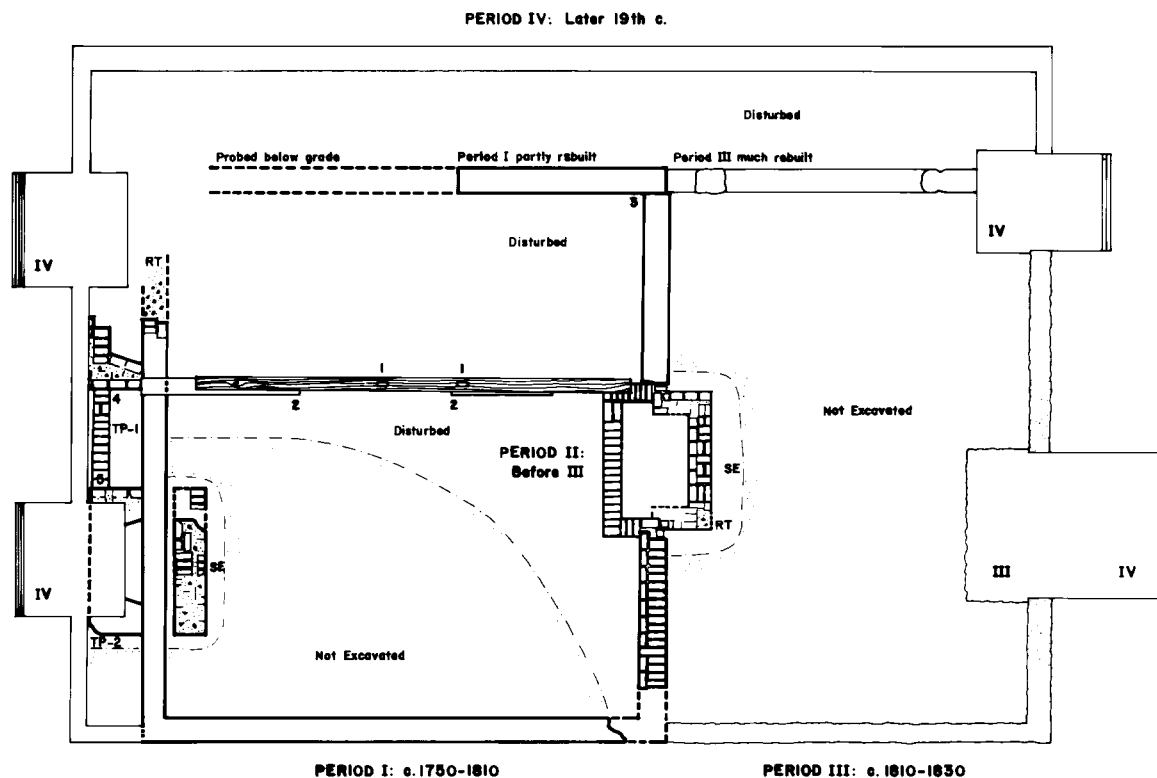
CT 59- B

PLAN OF FOUNDATIONS

- TP-1 Test pit to surface of construction backfill.
- TP-2 Test pit into robbers' trench revealed edge of chimney.
- RT Robbers' trench
- SE Shallow excavation
- ① Mortices for door frame in Period I or II sill.
- ② Footing rebuilt during Period IV.
- ③ Not bonded. Result of rebuilding or sequential construction.
- ④ Footing for probable steps. Period II.
- ⑤ Period I scored joints overlaid by mortar of Period II.
